Aviation Investigation Final Report

Location:	Arcadia, Iowa	Accident Number:	CEN22LA351
Date & Time:	August 1, 2022, 09:15 Local	Registration:	N169AA
Aircraft:	BELL HELICOPTER TEXTRON 206B	Aircraft Damage:	Substantial
Defining Event:	Loss of engine power (total)	Injuries:	1 Minor
Flight Conducted Under:	Part 137: Agricultural

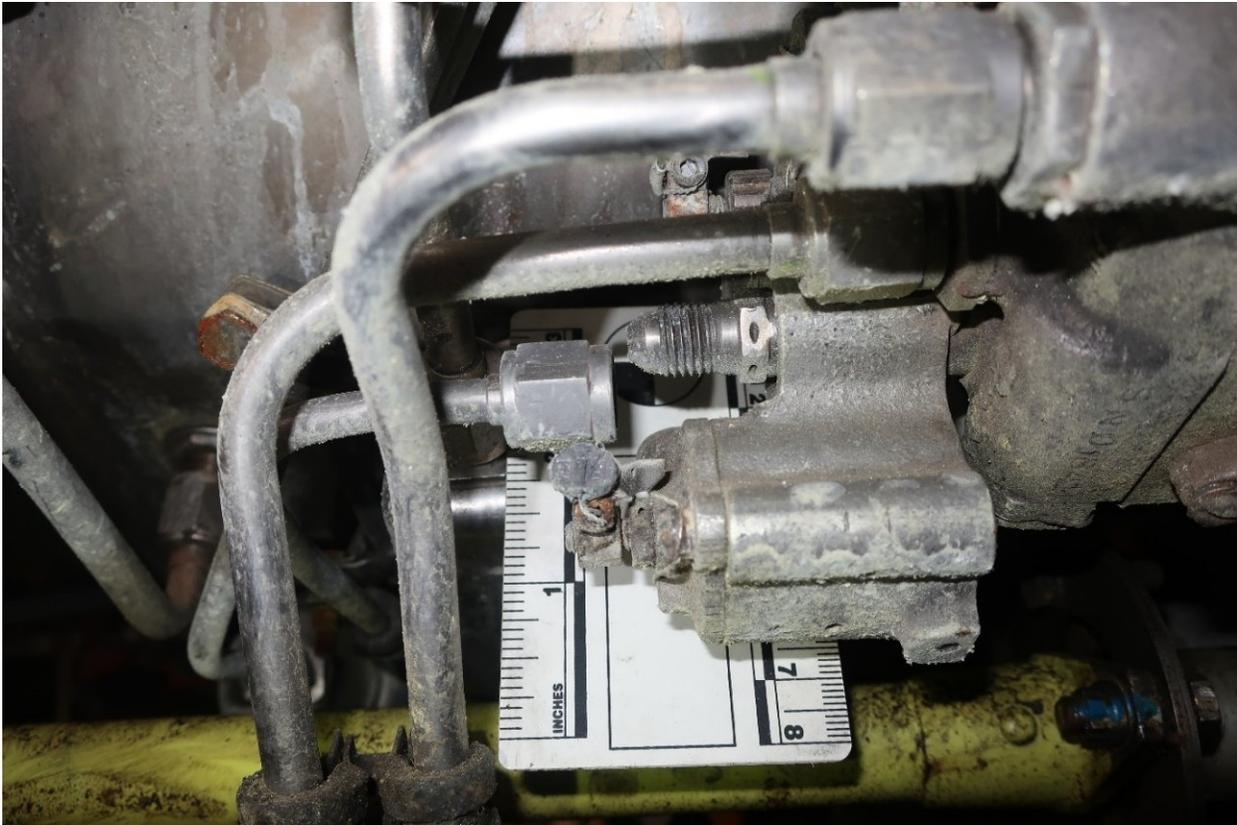
Figure

Maintenance was performed on the helicopter 23 days and 12 flight hours before the accident. It is likely that the maintenance personnel did not properly torque this B-but or apply torque stripe paint, which resulted in a disconnection of the B-nut and a loss of engine power.

Maintenance personnel's failure to properly torque a fuel control unit B-nut, which resulted in a loss of engine power at low altitude and an impact with terrain.

All external air, fuel, and oil line connections were at least finger tight except for the Pc line B-nut connecting the PTG to the FCU. The Pc line was not connected to the FCU and a gap was noted between the B-nut and FCU union (Figure 1). Residual torque paint was identified; however, there was no new-effective torque paint identified on any B-Nut. This Pc line is one of several that use air pressure to communicate fuel scheduling demands between the PTG and FCU.

1. Disconnected Pc line B-nut that connects the PTG to the FCU.

The only anomaly observed that would have precluded normal engine operation was the disconnected B-nut on the Pc line.

According to Rolls-Royce, the B-nut that was found loose is difficult to access when other tubes are installed. Rolls-Royce designed, developed, and released a special tool to access this B-nut. On October 24, 2016, it was released to the field via commercial service letter (CSL) 1273. The CSL provides details on how to manufacture the tool locally and the tool is also available for purchase. Operators are advised that torque paint/slippage indication is to be applied to all B-nuts per the Rolls-Royce operation and maintenance manual (OMM). Strict adherence to the specified manuals is essential to the safe and reliable operation of the engine. Failure to maintain the engine in accordance with the OMM and supporting customer publications can result in a decrease in airworthiness of the engine.
