Mould: A Growing Issue

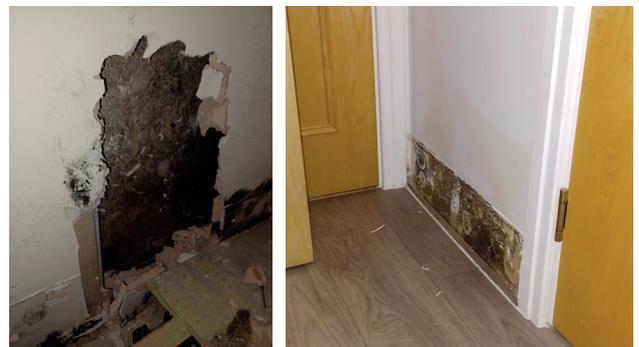
In the pictured examples, minor surface growth was evident and, in both examples, overpainted. Further investigations into both cases subsequently identified significant growth on the backs of plasterboard and ongoing leaks.
